AERIAL PHOTOGRAPHIC ANALYSIS LUSHER AVENUE GROUNDWATER CONTAMINATION STUDY AREA Elkhart, Indiana

TS-PIC-201105002S
April 2012

AERIAL PHOTOGRAPHIC ANALYSIS OF
LUSHER AVENUE GROUNDWATER CONTAMINATION STUDY AREA

Elkhart, Indiana

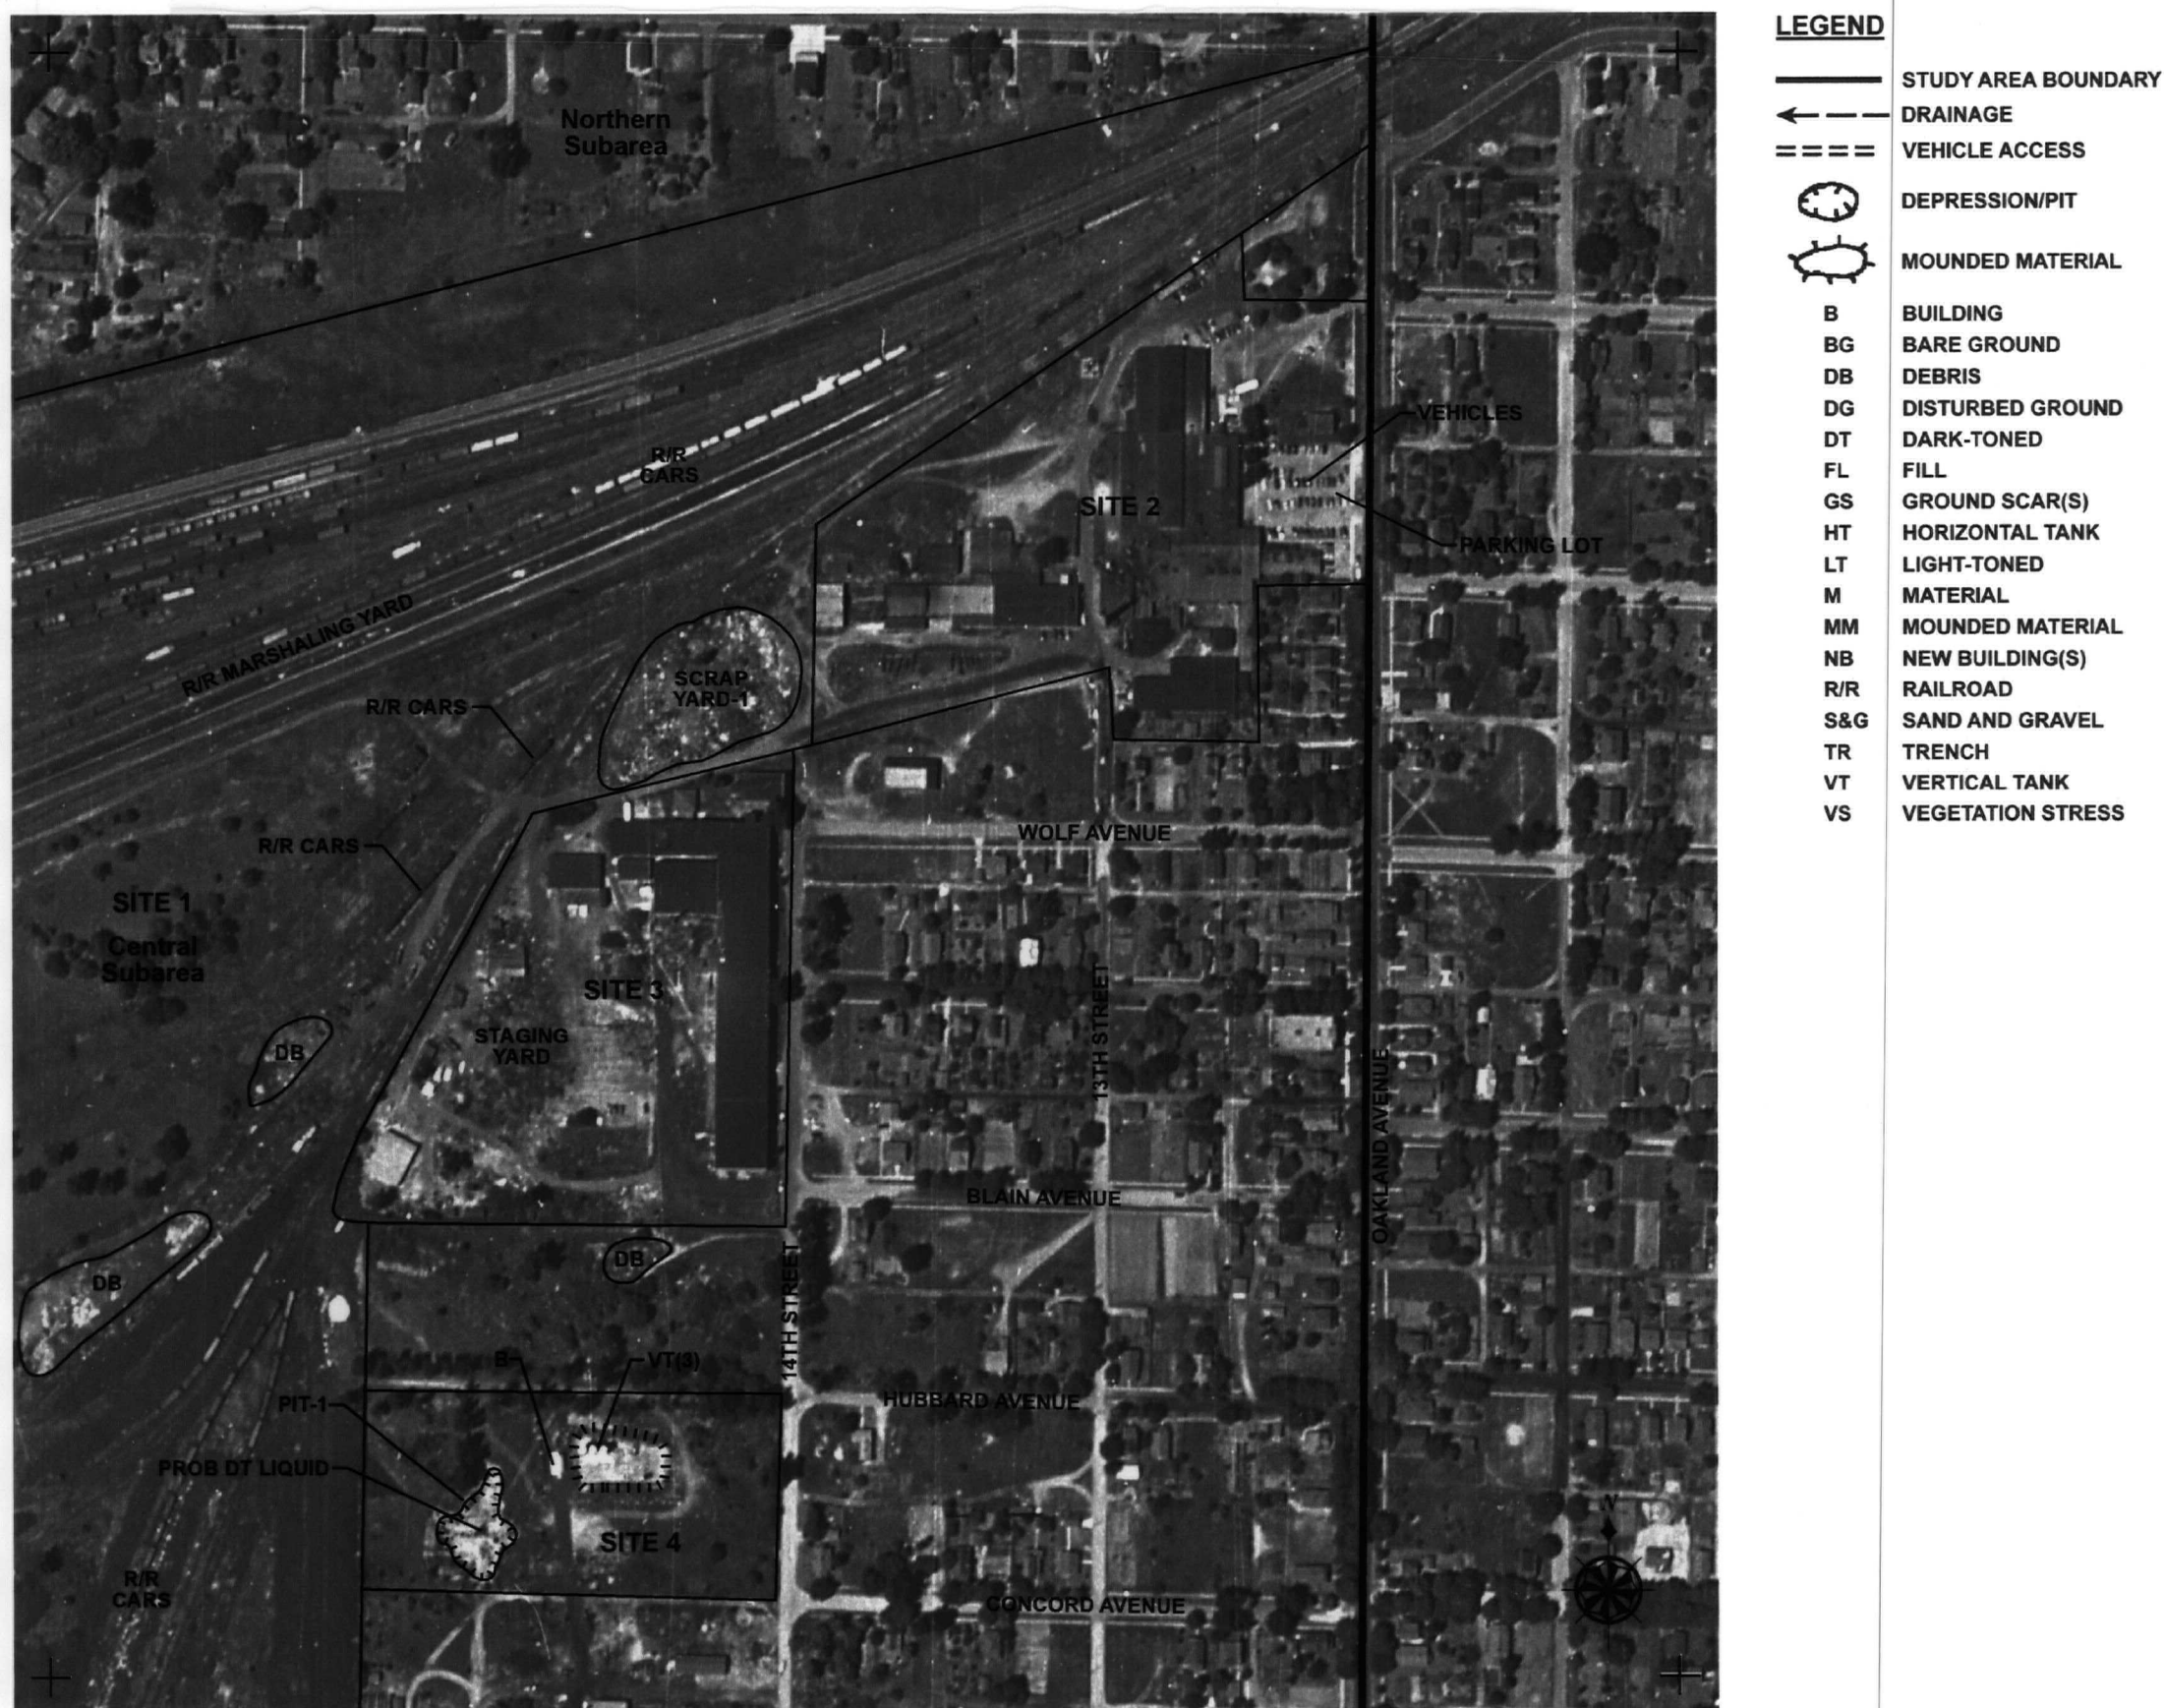
Figure 5. Lusher Avenue Groundwater Contamination study area, July 6, 1951.
Approximate scale 1:3,300.

Site 3 - This industrial facility appears to be in use and is a probable scrap/recycling operation. A staging yard has been established west of the main building and contains piles of dark- and light-toned material.

Site 4 - A fuel/oil distributor facility, along the western side of 14th Street between Hubbard and Concord avenues, contains one small building, a group of three vertical storage tanks (VT), and a large unlined open pit southwest of the storage tanks. The facility appears to be unpaved and accessed by dirt driveways from 13th Street and Concord Avenue. The three vertical storage tanks are located within an unlined earthen secondary containment revetment. The irregular-shaped unlined open pit is approximately 50 meters x 30 meters (150 feet x 100 feet) and contains probable dark-toned (DT) liquid.

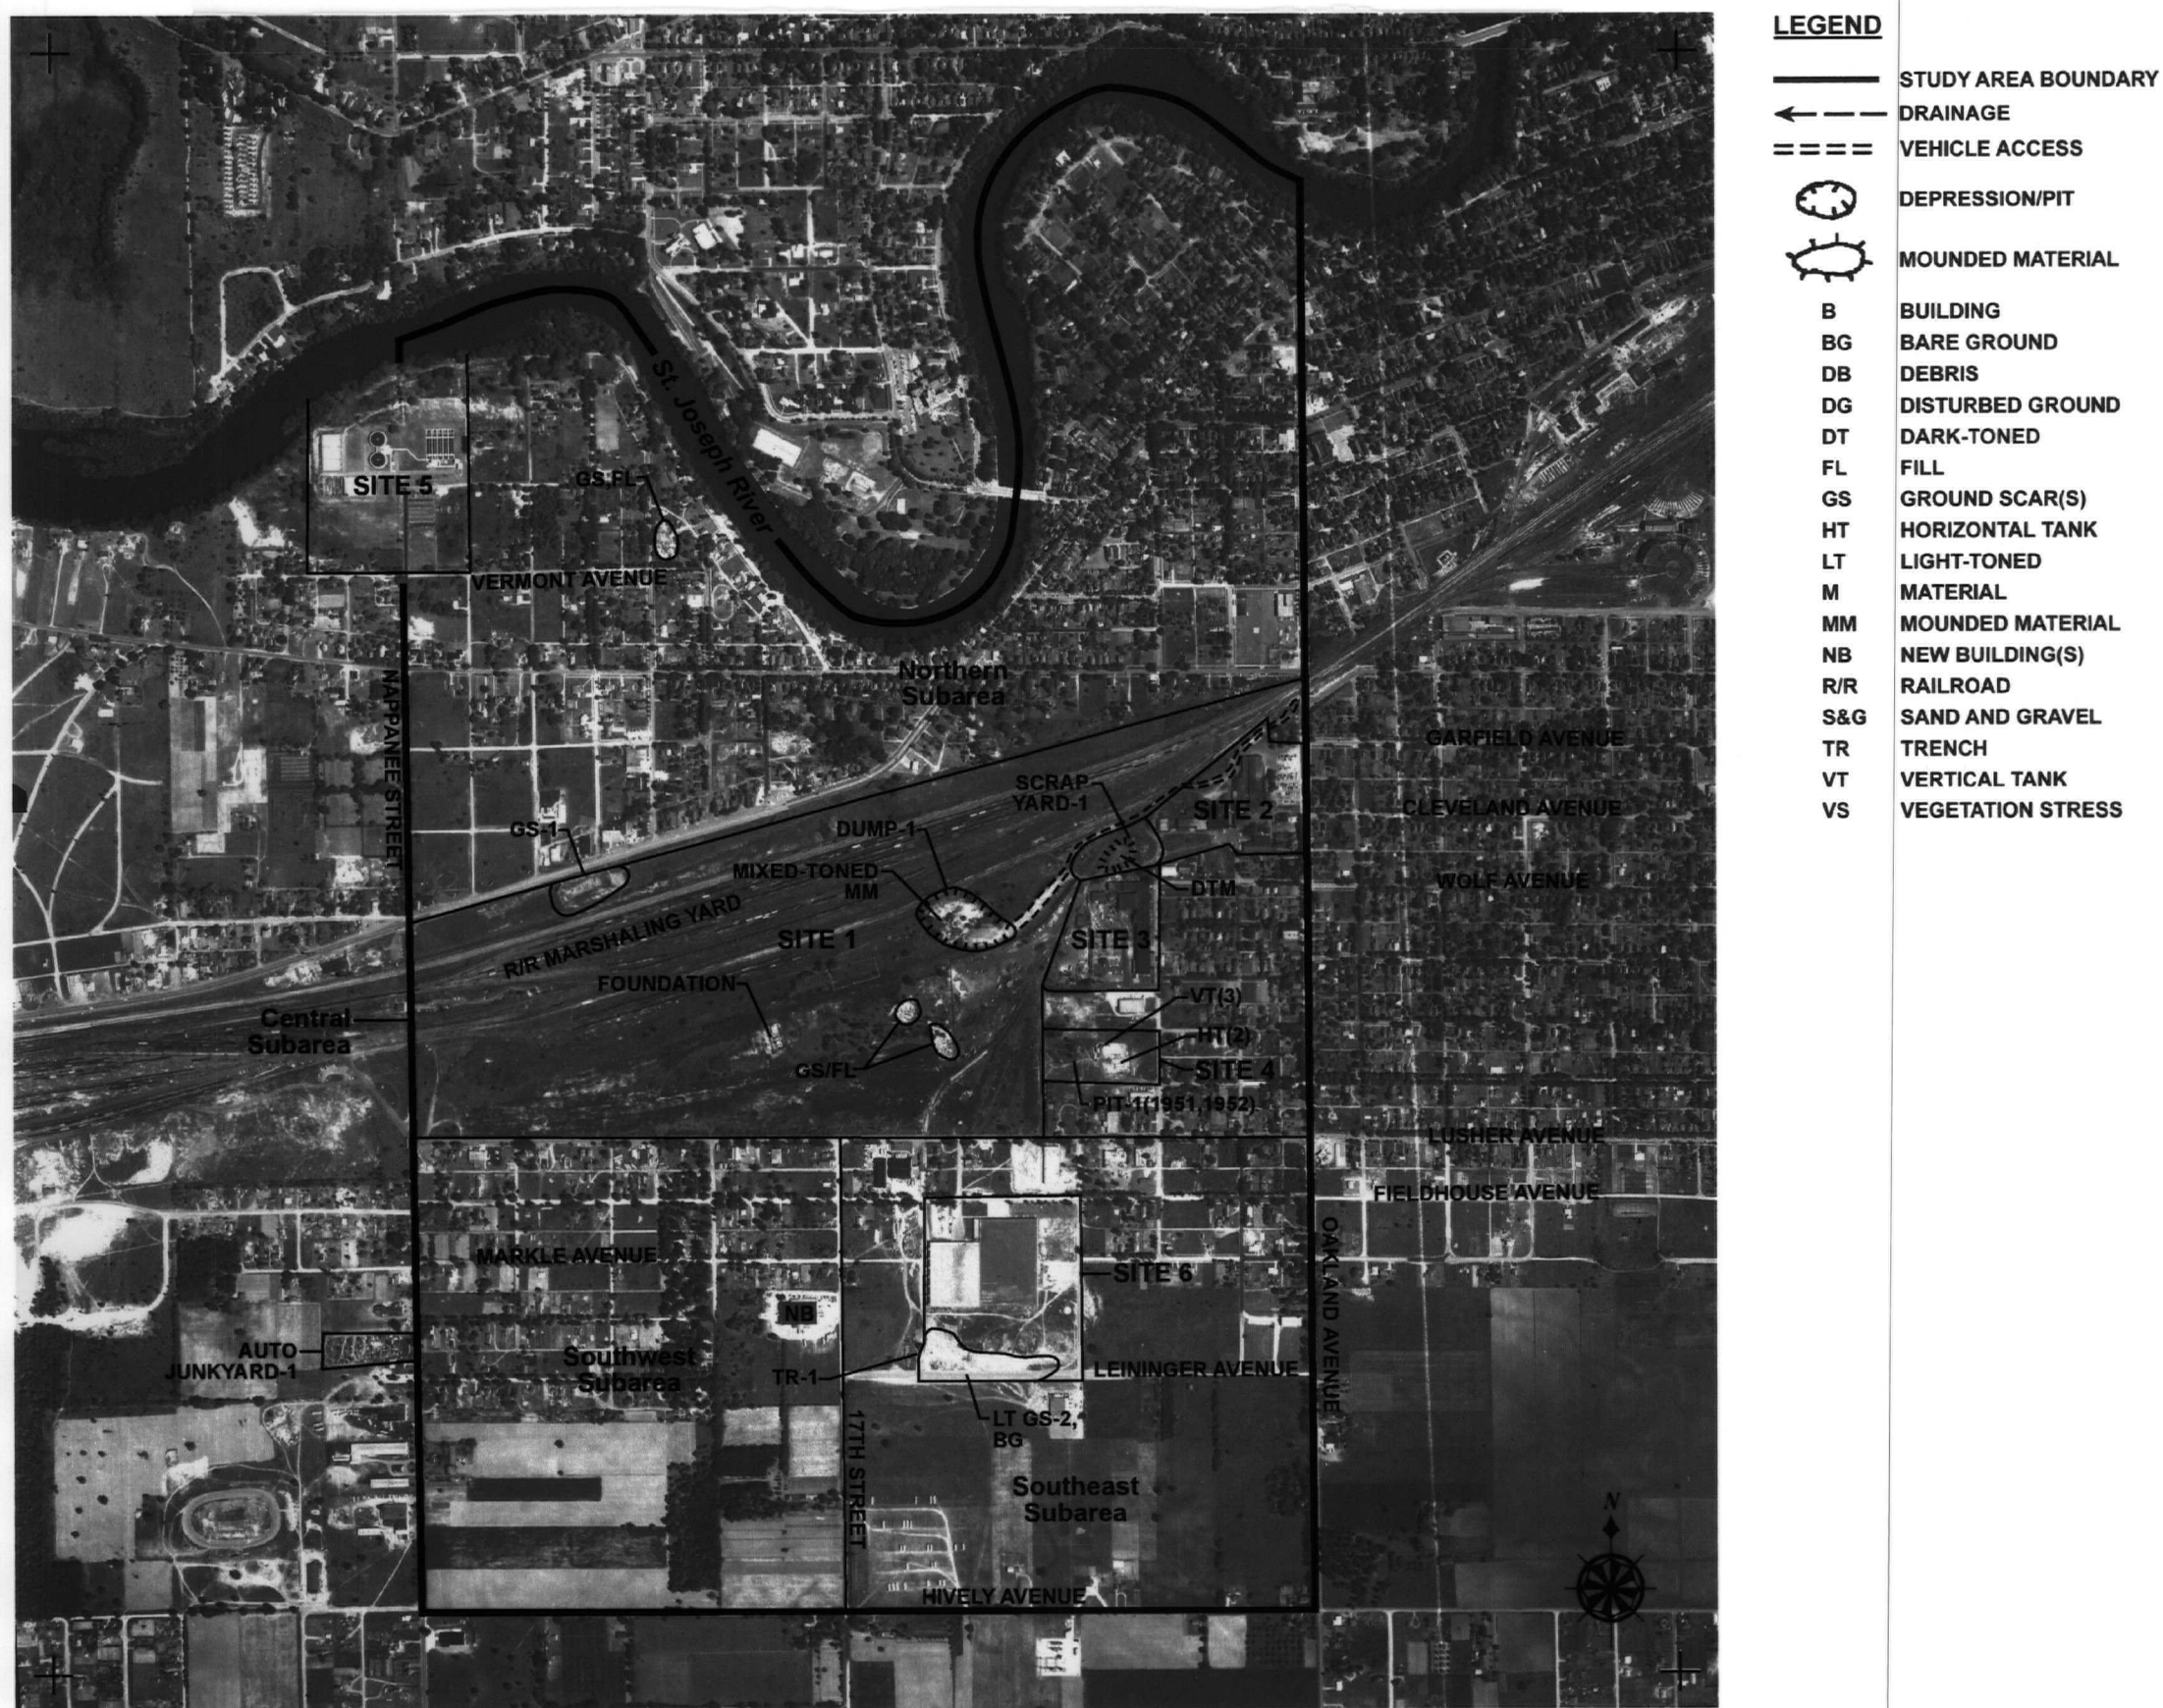
Figure 6. Lusher Avenue Groundwater Contamination study area, June 3, 1957.
Approximate scale 1:12,700.

A location with disturbed ground (DG) and fill material (FL) is noted east of Site 5. These features appear to be associated with construction.

An open dump (Dump-1) is observed at a terrain depression in the central portion of the railroad marshaling yard. Mixed-toned mounded materials (MM) have been deposited at this dump.

Site 2 - The industrial manufacturing facility remains operational. Scrap Yard-1 on the western side of the facility appears to have been partly cleared of the piles of material noted in 1951. One pile of dark-toned material (DTM) (probable scrap metals) remains.

Site 6 - The commercial facility has two large buildings and a large staging yard near the buildings. A light-toned ground scar (GS-2) and bare ground (BG) are observed along the northern side of Leininger Avenue. A small open trench (TR-1) is visible at the western side of ground scar GS-2. The presence of the trench may indicate waste disposal activity at this facility.

Auto Junkyard-1 - Offsite and west of Nappanee Street an automobile junkyard has been established.

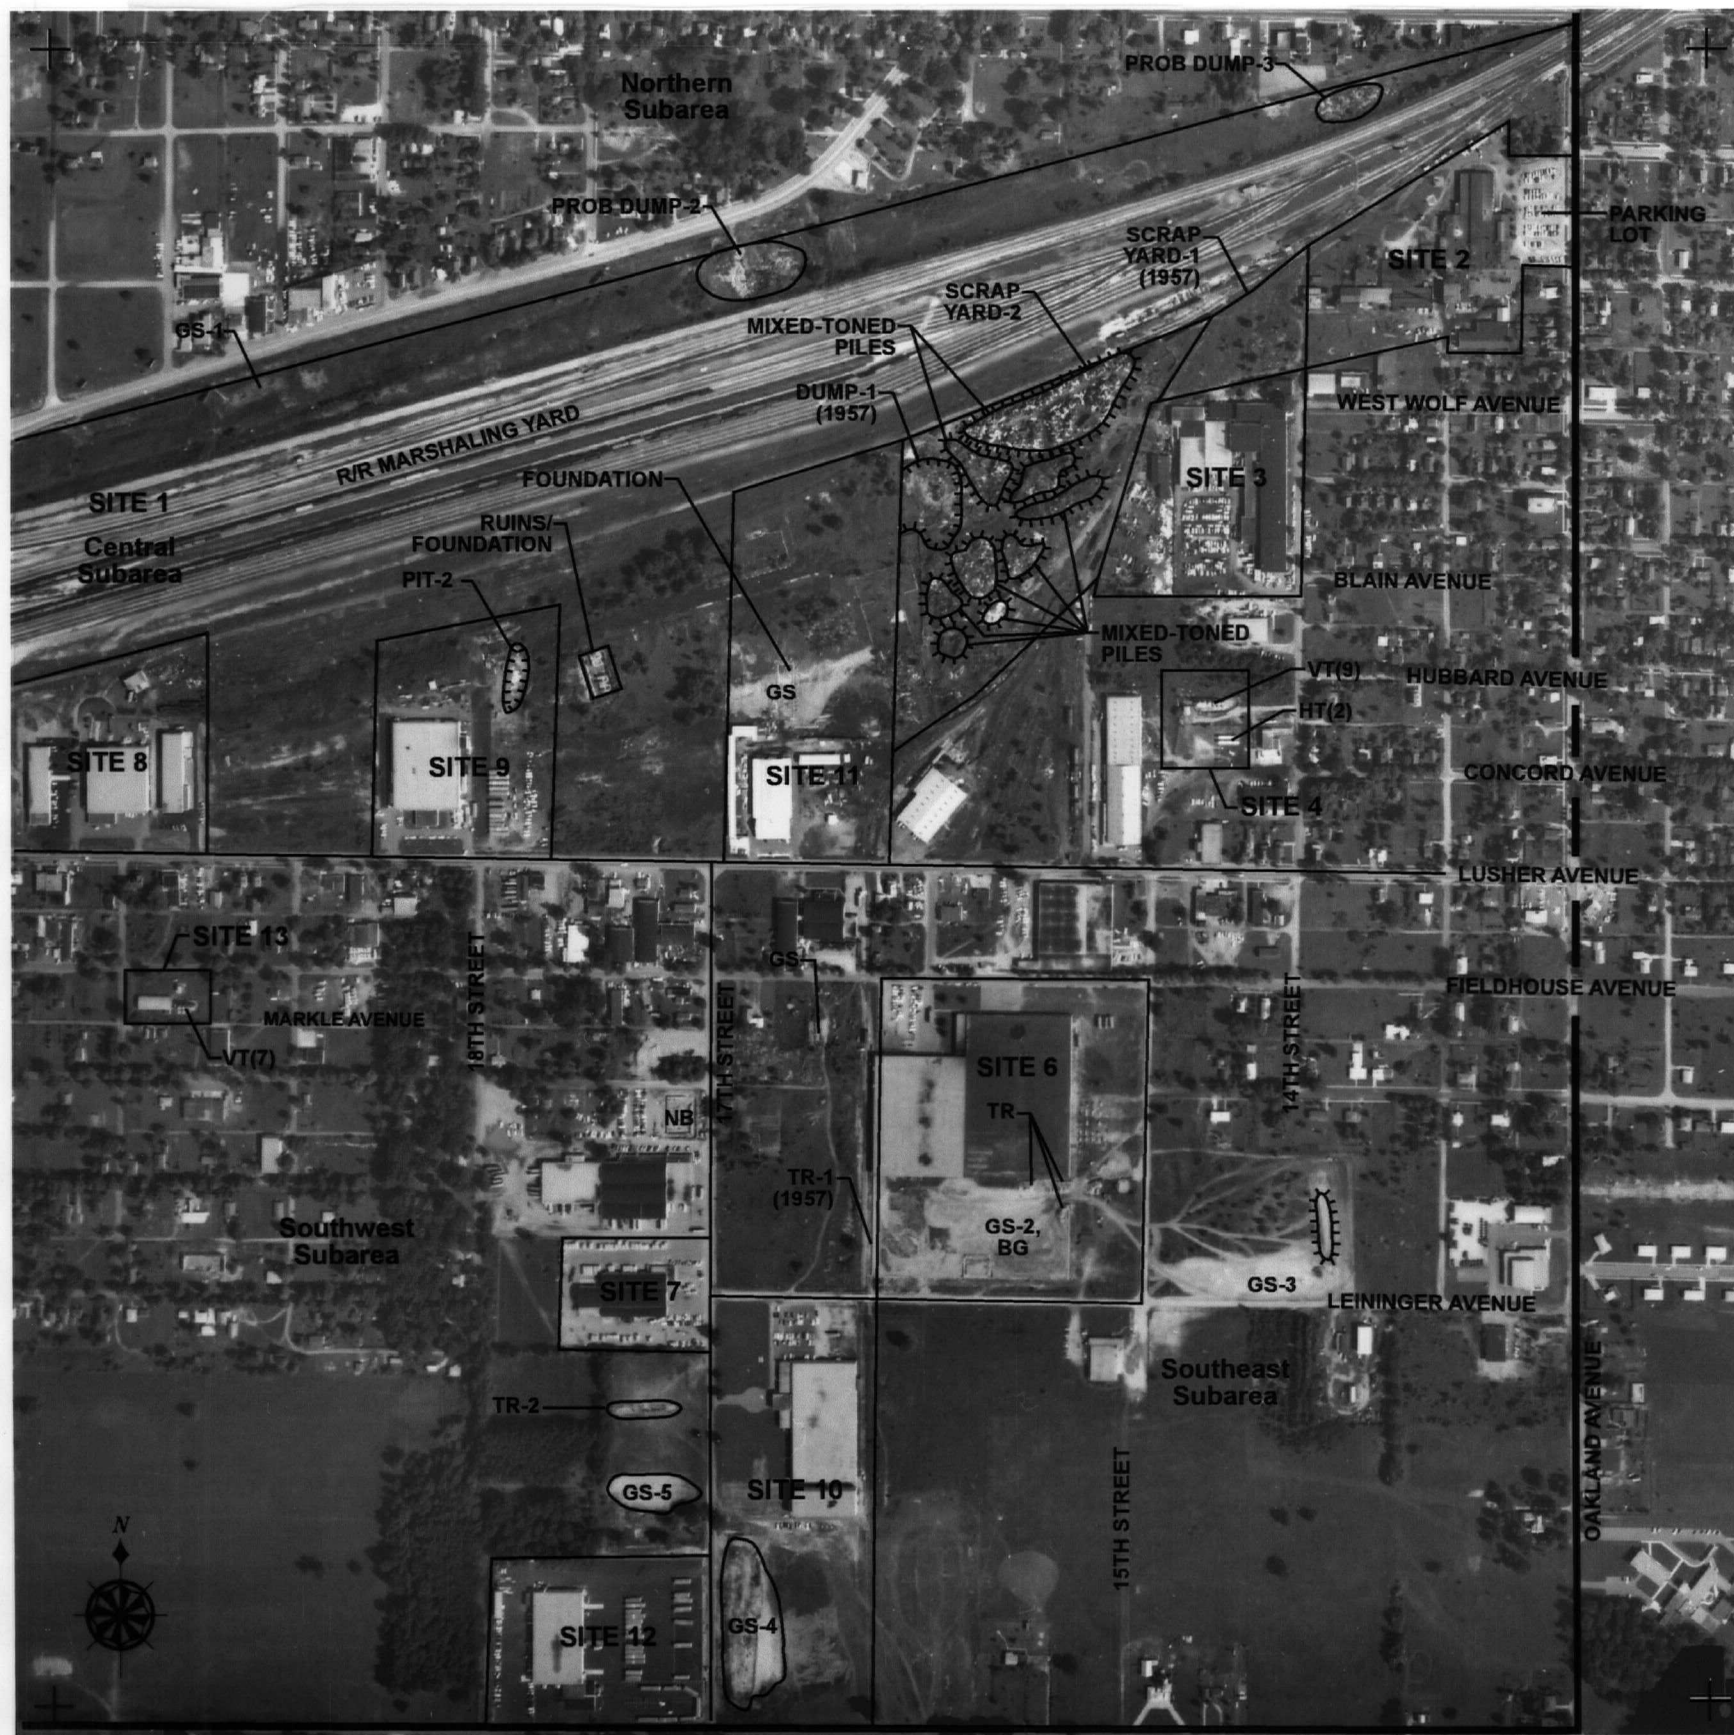
Figure 8. Lusher Avenue Groundwater Contamination study area, August 20, 1965.
Approximate scale 1:7,100.

Site 2 - The industrial manufacturing facility remains operational and vehicles are in the employee parking lot. Scrap Yard-1, noted on the western side of the facility in 1957, is absent and the area appears free of piles of mixed-toned material.

Site 11 - A commercial facility under construction within the railroad marshaling yard, near the intersection of Lusher Avenue and 17th Street, contains one large building and three support buildings. Another building foundation and ground scars are evident in the northern portion of the facility.

GS-5 - A large ground scar with an east-west orientation is observed between Site 7 and Site 12, south of trench TR-2. The ground scar is accessed by a trail from 17th Street. The ground scar in proximity to trench TR-2, may be associated with disposal activity related to trench TR-2.

Site 6 - The commercial facility remains operational. Ground scar GS-2 and the bare ground noted on the southern side of the buildings in 1957 remain. Three trenches are noted near the southeastern corner of the main building and may be associated with nearby construction activity. Trench TR-1 observed in 1957 is no longer discerned. Construction activity in this area is suspected. An additional ground scar and vehicle tracks are visible in the open lot west of the site.

Site 10 - A commercial facility has been constructed along the eastern side of 17th Street and south of Leininger Avenue. The facility contains two buildings and a staging area at the northern side of the property along Leininger Avenue.

GS-4 - A large ground scar is observed in the southern portion of Site 10. The ground scar has linear patterns of earth that suggest trenches may have been dug and filled in this disturbed area.

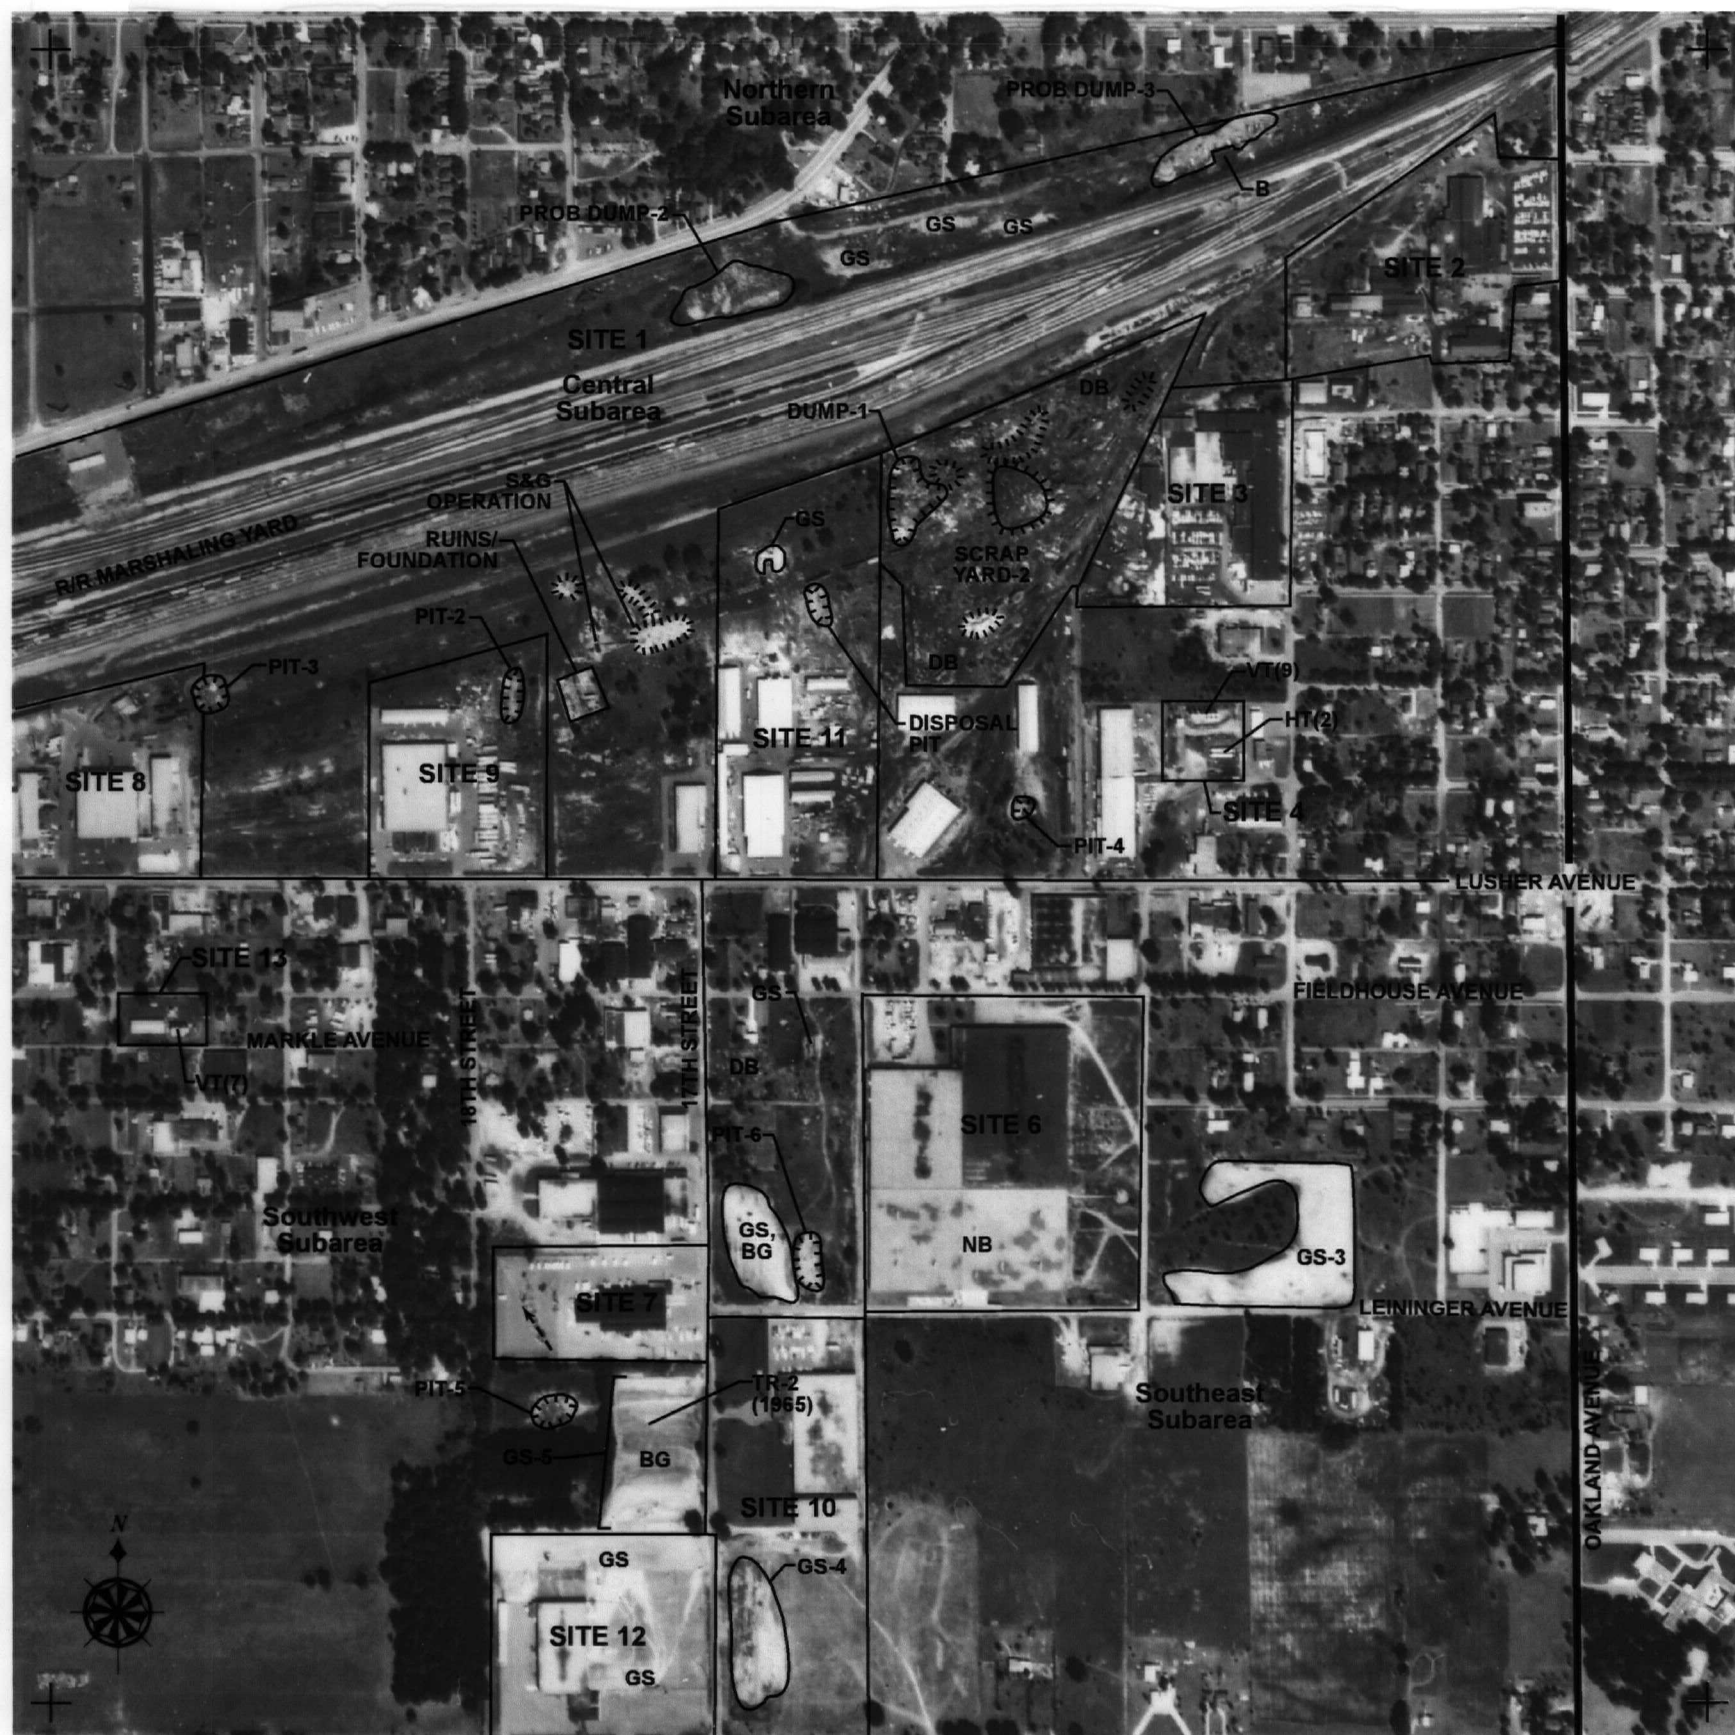
Figure 10. Lusher Avenue Groundwater Contamination study area, August 28, 1967. Approximate scale 1:7,120.

Site 1 - The railroad marshaling yard remains operational and railroads cars are present. Dump-1, located in a depression within the railroad marshaling yard, is served by dirt roads and continues to receive solid waste. A dark stain is noted at the bottom of the depression. Scrap Yard-2 has been extended onto Dump-1 so that it is difficult to discriminate between piles of solid waste and mounds of scrap material. Scrap Yard-2 now contains very large mounds of mixed-toned material (probable scrap metals).

Dump-2 remains active along the north central perimeter of the railroad marshaling yard. Most of Dump-2 is covered with piles of mixed-toned material. Dump-3 remains in place near the northeastern perimeter of the railroad marshaling yard. Most of Dump-3 is covered with piles of mixed-toned material. Three ground scars are observed between Dump-2 and Dump-3.

Pit-4 - A disposal pit is observed west of Site 4 and east of 16th Street. The pit contains light-toned material and possible sludge. The light-toned material is also spilled around the rim of the pit.

Site 8 - The commercial facility at the intersection of Lusher Avenue and Nappanee Street remains operational. An unlined disposal pit (Pit-3) is discerned in the northeastern corner of the facility, adjacent to the railroad tracks. Light-and dark-toned material is observed at the bottom of the disposal pit.

Site 11 - The commercial facility along Lusher Avenue and east of 17th Street appears operational. Three buildings have been built in the northern portion of the facility where a large ground scar was observed in 1965. A possible disposal pit is discerned in the northern portion of the property. The pit contains debris. A ground scar is observed north of the possible disposal pit.

GS-5 - The area of ground scars and bare ground has been expanded; it now extend along the western side of 17th Street from Leininger to Hively avenues. The ground scars do not appear to be related to construction site preparation. The ground scars may indicate possible waste disposal activity at this location. The ground scars are in proximity to the location of the former open disposal trench TR-2 and the nearby disposal pit Pit-4 noted in 1965.

Pit-5 - A disposal pit has been dug west of the previously observed open disposal trench TR-2. This new disposal pit appears to contain debris. The new pit is only accessible via a dirt road connecting to 17th Street.

Site 12 - The commercial facility appears vacant and in transition. All of the truck trailers observed at the facility in 1965 are absent. No vehicles are discerned. Ground scars are visible across the parking apron and extend north into the large ground scar GS-5.

Pit-6 - A disposal pit has been dug north of Site 6 along the northern side of Leininger Avenue. The objects at the bottom of the pit can not be identified. A large ground scar and bare ground are visible on the western side of the pit. Another ground scar and debris are visible north of Pit-6.

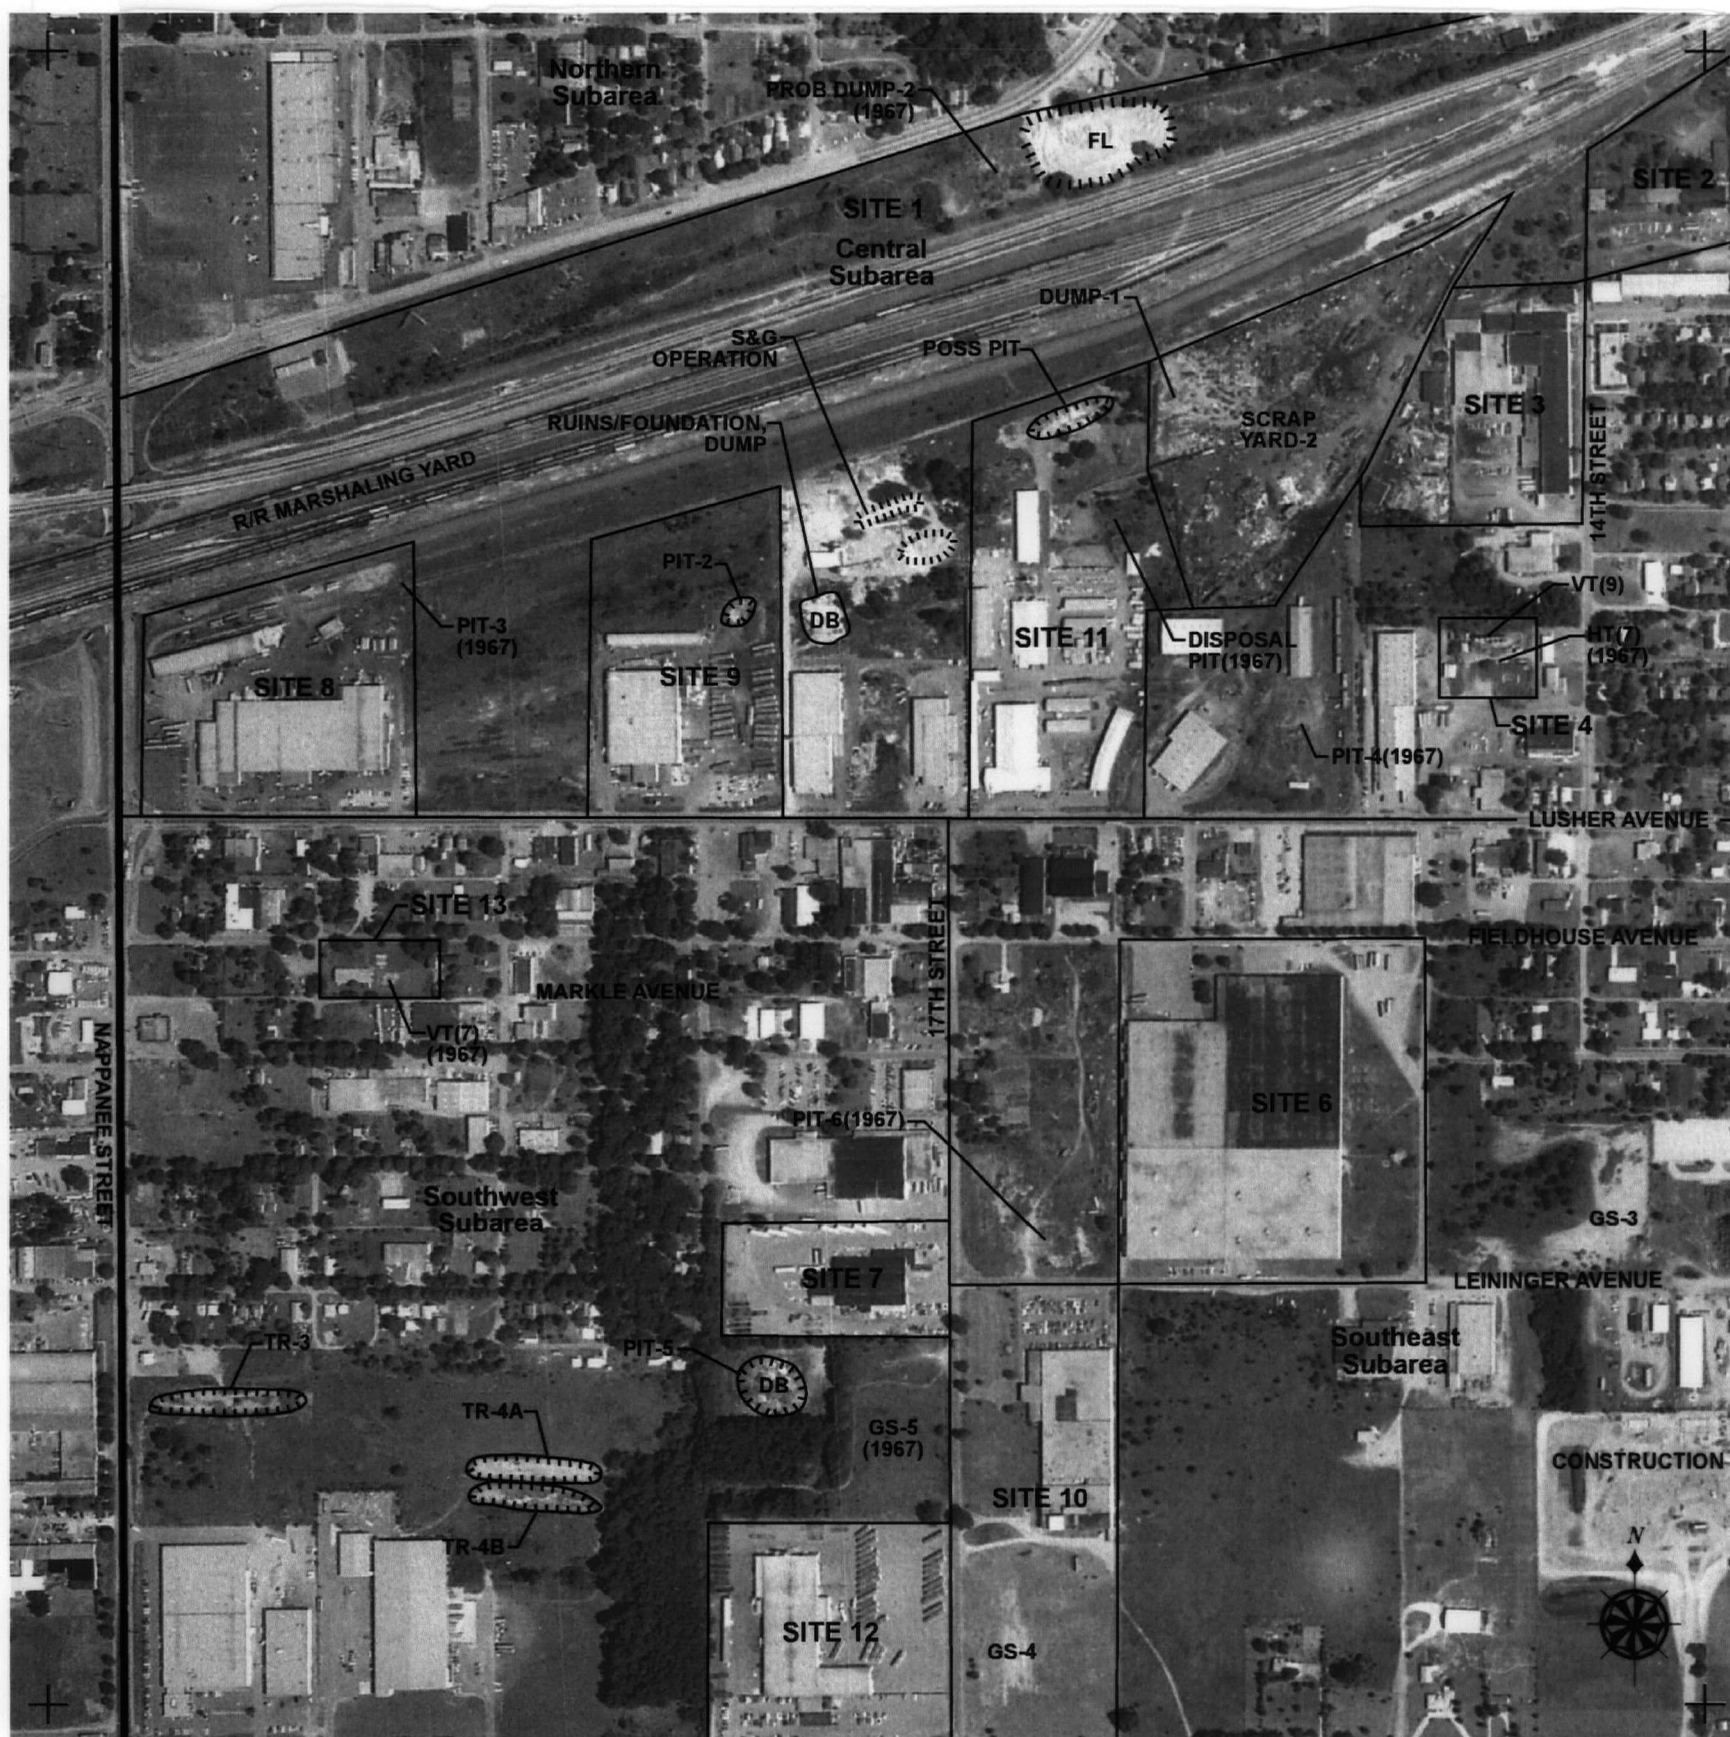
Figure 12. Lusher Avenue Groundwater Contamination study area, July 13, 1973. Approximate scale 1:6,640.

Site 4 - The fuel/oil distributor facility appears operational. The two previously observed horizontal storage tanks have been removed.

Pit-4 - The disposal pit, observed in 1967, is absent and the area has been leveled and graded. The spillage of light-toned material around the former pit is not evident.

Site 8 - The commercial facility remains operational. Unlined Pit-3, noted in 1967, is not discerned.

Sand and Gravel - The sand and gravel operation remains operational. The extent of the bare ground and the light-toned sand-gravel stockpiles at the facility has increased compared to what was observed in 1967. The nearby location of the ruins/foundation has become an open dumping location and contains piles of debris.

Site 11 - The commercial facility remains operational. The possible disposal pit noted in 1967 is not discerned; however, another possible disposal pit has been dug near the northern perimeter of the property. This new, possible disposal pit contains debris.

Site 13 - The probable fuel/oil distributor is likely no long operational; the seven vertical storage tanks have been removed. No ground scars are visible at the site to suggest underground storage tanks have been installed to replace the absent storage tanks.

Pit-6 - The previously observed disposal pit is absent. The ground has been leveled although the area still appears disturbed and has numerous ground scars. No waste disposal activity is noted.

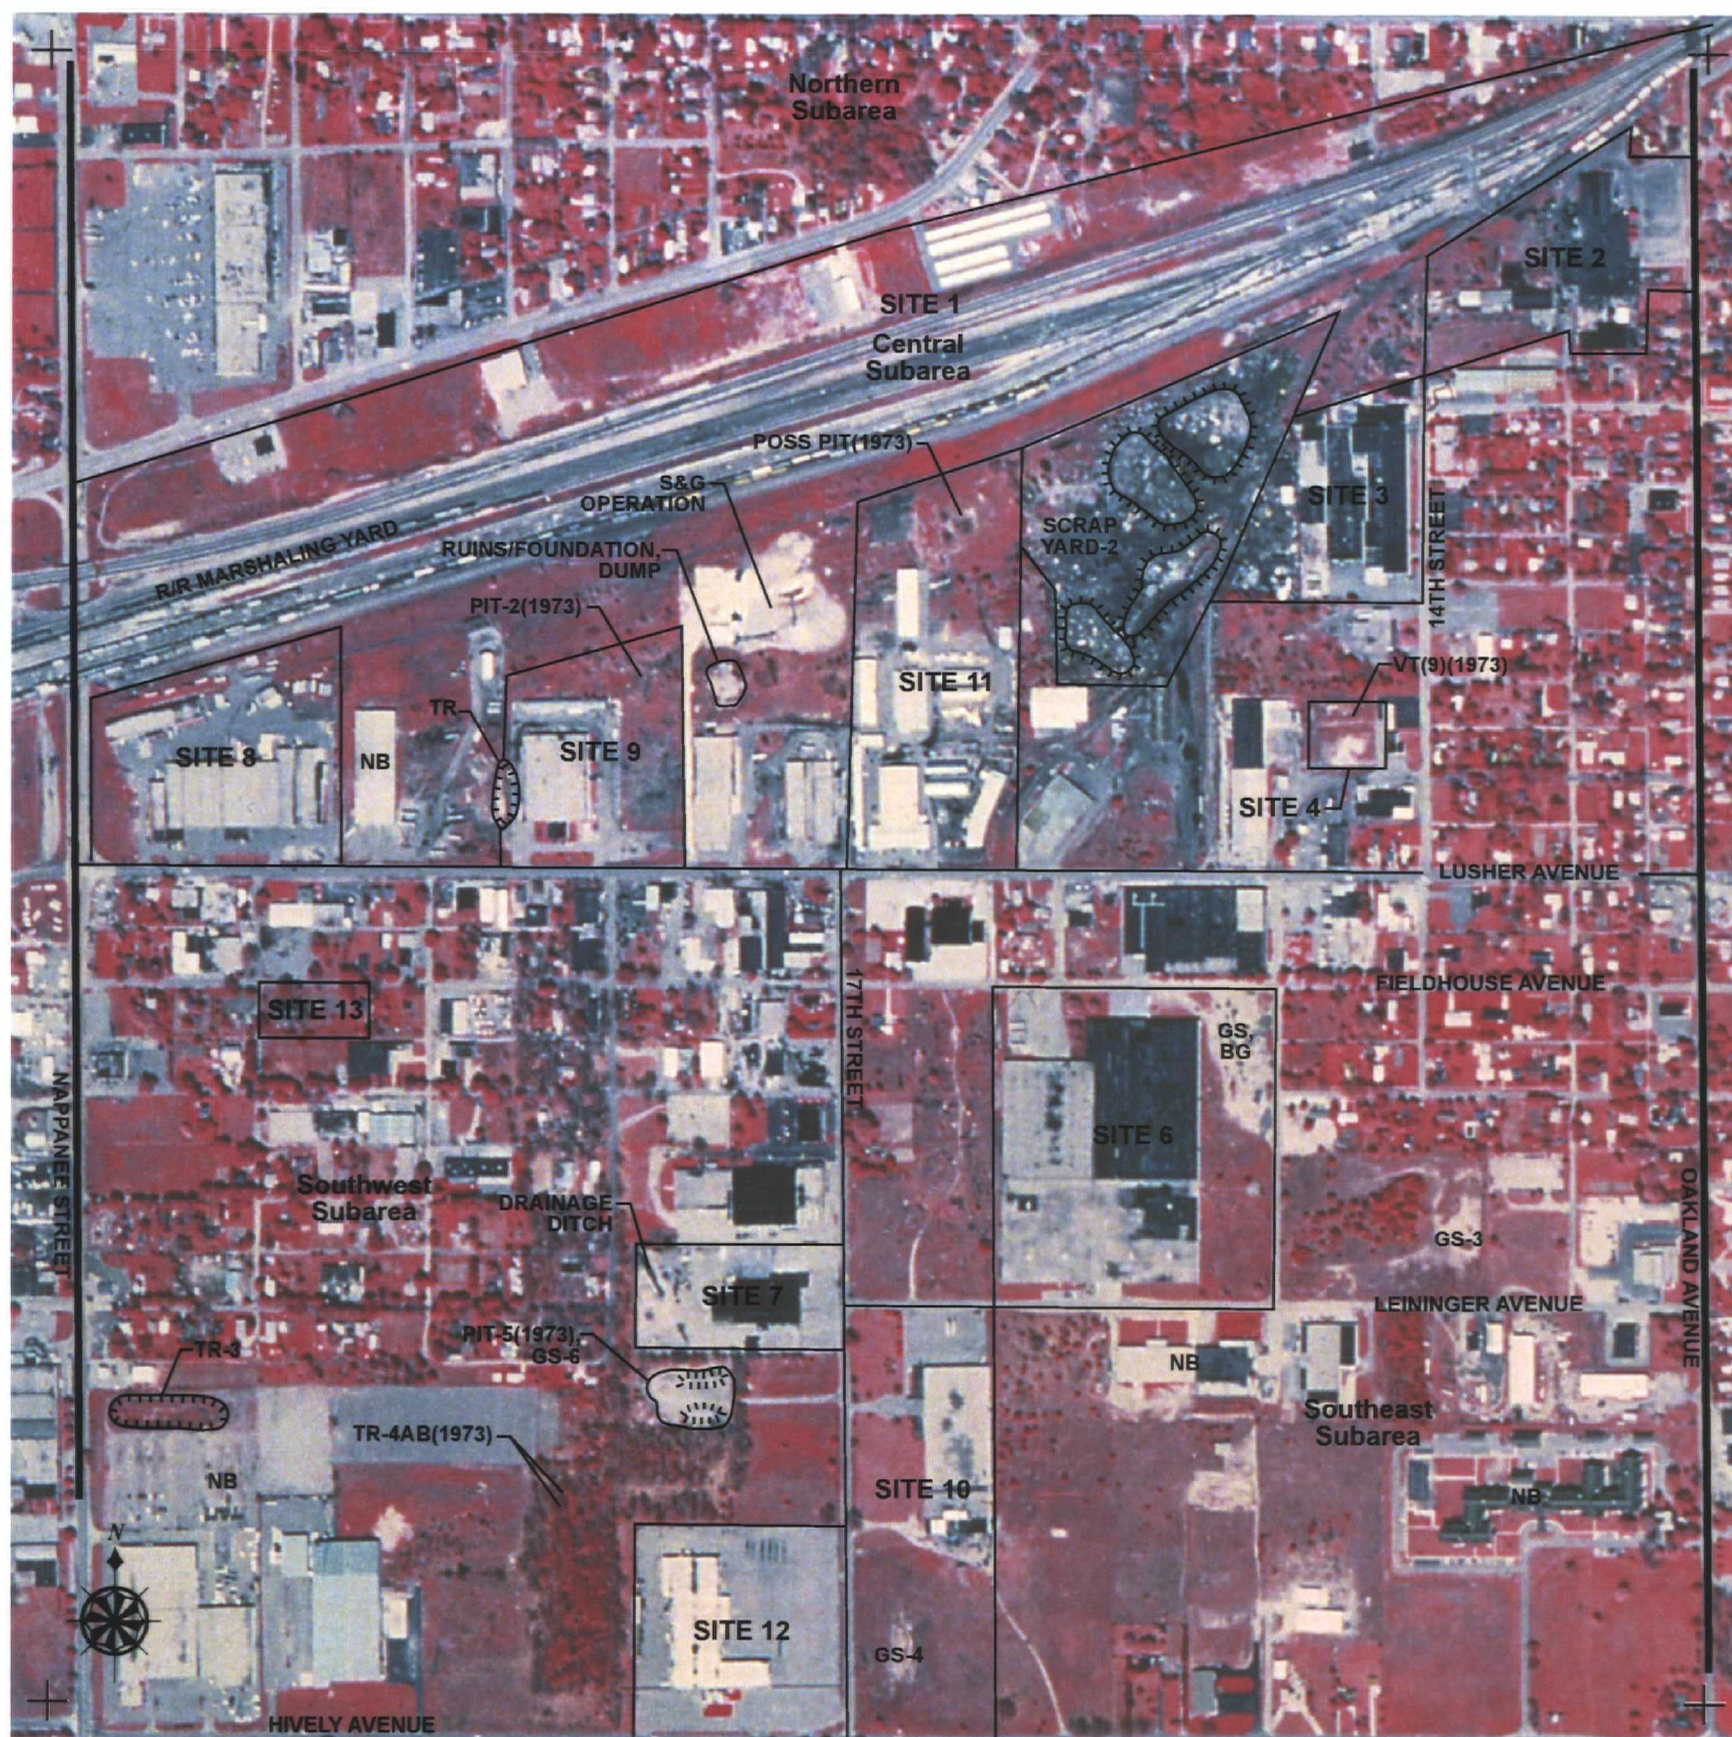
Figure 14. Lusher Avenue Groundwater Contamination study area, May 2, 1981.
Approximate scale 1:7,120.

Site 4 - The previously observed fuel/oil distributor is absent. All storage tanks have been removed.

Site 9 - The commercial facility remains operational. Pit-2 observed at the northern portion of the property in 1973 is no longer evident. Dumping at this location appears to have ceased and the area has become overgrown. A new probable disposal trench has been dug along the western side of the main building.

Site 11 - The commercial facility appears operational. The disposal pit noted in 1973 is not evident and the location has become overgrown. Dumping at this location appears to have ceased.

GS-6 - The disposal pit (Pit-5) observed in 1973 is absent and waste dumping at this location appears to have ceased. Mounded material, probably fill or soil, are now observed at this location.

TR-4A/TR-4B - The two parallel unlined possible disposal trenches observed in 1973 are absent. The location has been leveled and revegetated.
